THE CRASH AND FIELD PERFORMANCE OF SIDE-MOUNTED AIRBAG SYSTEMS

Transport Canada

Paper No. 442

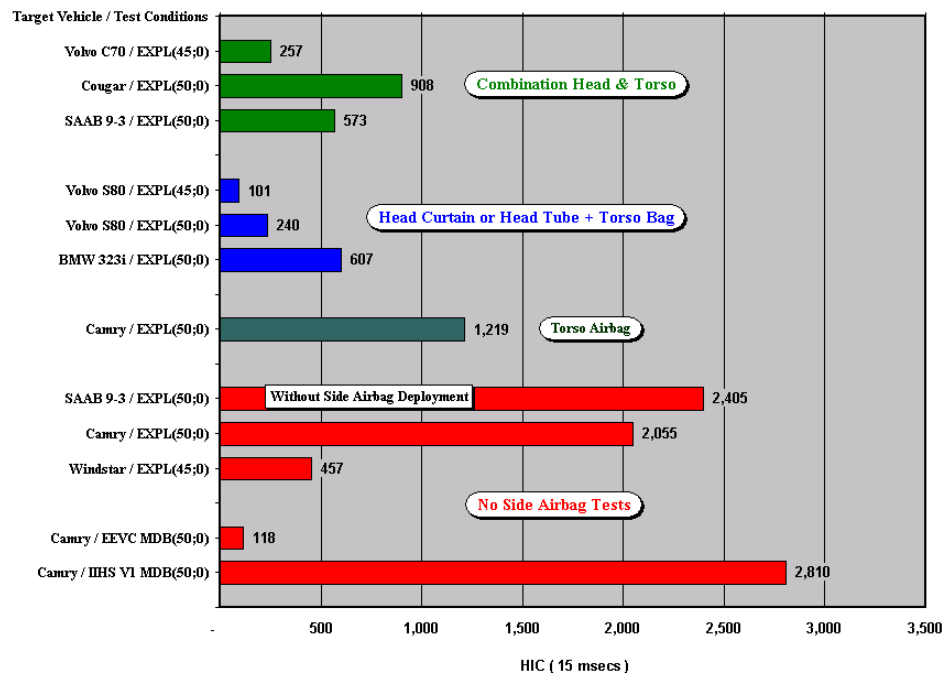
Figure 1. Peak Driver (SIDIIs) HIC Values Recorded In Perpendicular Explorer and MDB Tests

respect to head protection in vehicle-to-vehicle impacts where the striking vehicle is an MPV with an elevated hood line. The SIDIIs driver Head Injury Criterion (15 ms) values observed in the subset of tests in which the target vehicle was impacted by a Ford Explorer in a straight perpendicular impact (10 tests) are summarized in Figure 1. For comparative purposes, the corresponding results obtained with the EEVC MDB and the IIHS MDB in perpendicular tests of one of the target vehicle models, the Toyota Camry, are also included in Figure 1. The same findings for the series of tests where the bullet vehicle was run in a crabbed mode are summarized in Figure 2.

Two tests were performed to establish the baseline level of head injury risk in a pure perpendicular SUV-to-car side impact at 50 km/h. The vehicle models tested for this purpose were a Toyota Camry not fitted with any side airbag, and a SAAB 9-3 with the side airbag system deactivated. Driver head contact with the hood of the striking Ford Explorer was observed in both tests. The peak resultant head acceleration observed in the Camry test was 230 g with an associated HIC of 2,055. The SAAB-3 test produced nearly identical results, a peak resultant head acceleration of 258 g with an associated HIC of 2,405.

In comparison to the baseline tests, all of the head responses observed in this series of six tests were low. The driver HIC values ranged from a low of 101 to a high of 908. The peak driver resultant head acceleration values were all below 100 g. Head contact with the intruding hood of the Explorer was prevented in all three tests involving seat-mounted combination head and torso side airbags. In each of these tests, deployment of the combination airbag was achieved very early in the collision event and containment of the head was sustained through the dummy loading phase.

If one compares the findings presented in Figures 1 and 2, it can be observed that tests where the bullet vehicle was crabbed generally produced low HIC values in comparison with perpendicular impact tests. The test matrix was constructed to allow the effects of crabbing to be quantified under a variety of different test conditions. The influence of crabbing the bullet vehicle on driver HIC values is summarized in Figure 5. All three comparisons are based on the driver head responses obtained in tests of the Toyota Camry. Note that the target Camry models used in the Camry-to-Camry tests were equipped with torso airbags, while those in the Explorer-to-Camry tests and the IIHS MDB-to-Camry tests were not equipped with torso bags. As can be observed all of the crabbed tests produced significantly lower driver HIC values under similar test conditions (54 km/h crabbed test vs. 50 km/h perpendicular tests).

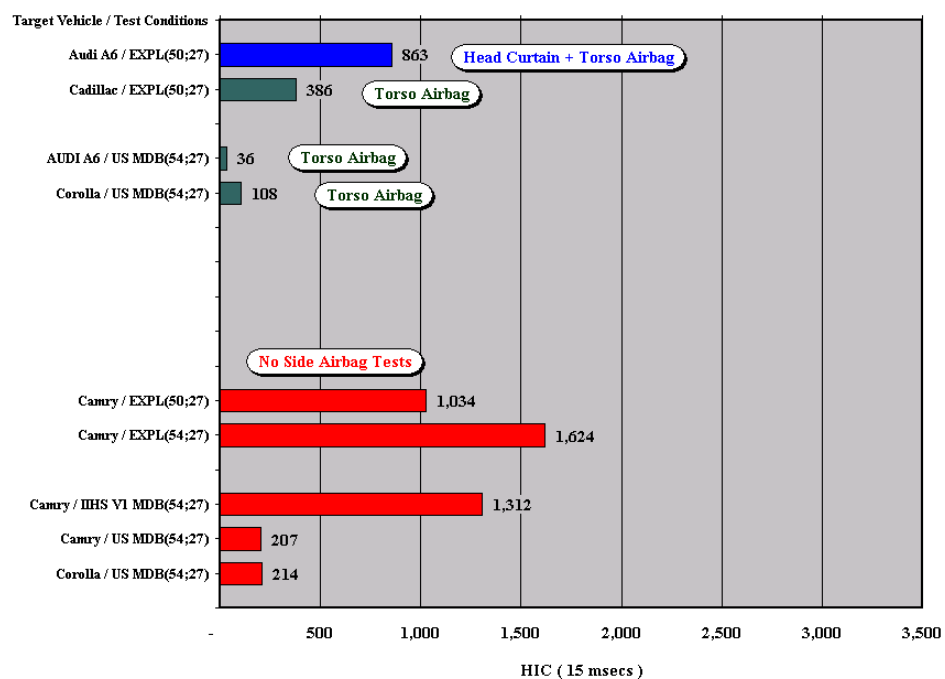
Figure 2. Peak Driver (SIDIIs) HIC Values In Crabbed Explorer and MDB Tests

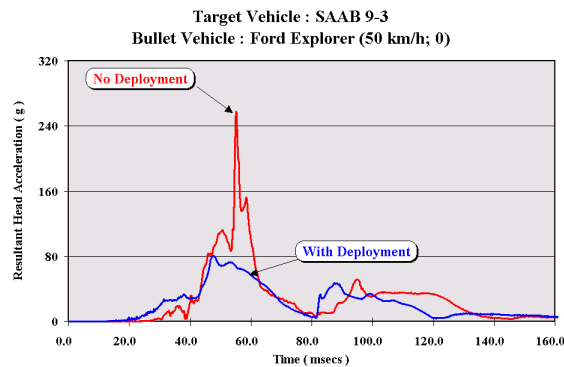
Figure 3. Head Accelerations (SAAB 9-3 Test)

and torso airbag was clearly evident. A comparison of the driver head responses observed in these two tests is depicted in Figure 3. With deployment, the peak acceleration was reduced from 258 g to 81 g the

associated HIC values were reduced from 2,405 to 573 respectively.

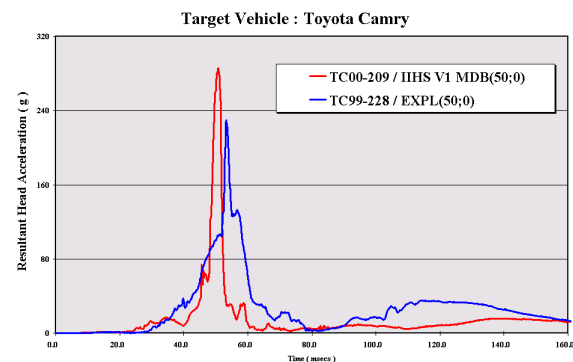
Figure 4. Explorer Test vs. IIHS-TC MDB Test

The Toyota Camry was also subjected to two perpendicular 50 km/h MDB tests, one with the EEVC barrier and one with the IIHS barrier. As the EEVC barrier was designed to represent a typical passenger car, owing to the absence of direct head contact, the test produced a relatively low driver HIC value (118). The test with the IIHS barrier produced direct contact of the driver's head with the barrier face. Despite the reduced mass of the barrier (1,500 kg), the test yielded a HIC value greater than that observed in the Explorer-to-Camry test (2,810 vs. 2,055) performed under nominally the same test conditions. A comparison of the driver head responses observed in the IIHS test and the Explorer test is presented in Figure 4. Although head contact occurred earlier in the barrier the difference in timing was not significant.

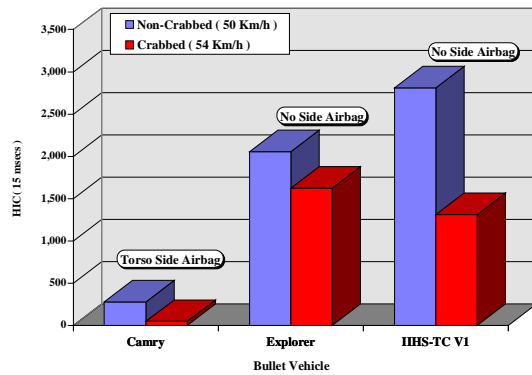
Figure 5. Influence of Crabbing on HIC Values

From the results presented in Figure 5, it can be further observed that the crabbed IIHS MDB test produced a driver HIC value, which although lower,

is reasonably comparable to that recorded in the crabbed Explorer test (1,312 vs. 1,624).

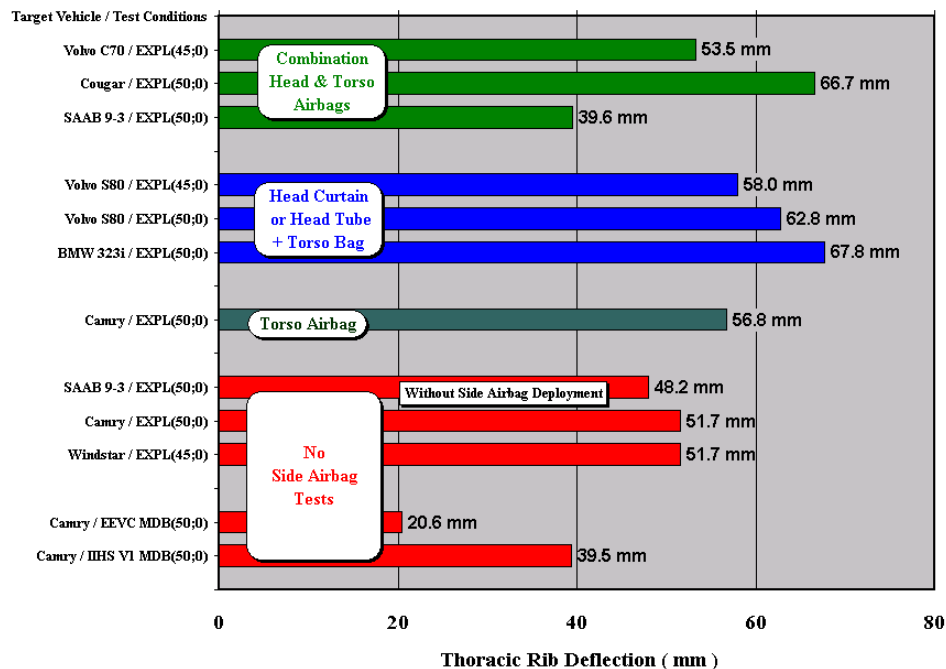
Figure 6. Driver Thoracic Rib Deflections Observed In Perpendicular Explorer and MDB Tests

The peak SIDIIs driver rib reflection values observed in the subset of tests in which the target vehicle was impacted by either a Ford Explorer or a MDB in a straight perpendicular impact are summarized in Figure 6. The corresponding data for tests where the bullet vehicle was crabbed are summarized in Figure 7.

With the exception of the SAAB 9-3, all of the vehicle models subjected to perpendicular impacts with the Ford Explorer showed relatively elevated peak thoracic rib deflection values, with one or more rib deflection exceeding 50 mm. This was true even when the impact speed was reduced from 50 km/h to 45 km/h. The elevated load paths produced in these

At face value, the overall results presented in Figures 6 and 7 would suggest that current side airbag systems afford no added benefit in terms of reduced thoracic injury risk. This is not exactly the case. Direct comparisons of the deflections observed across both the thoracic and abdominal rib elements, as a function of airbag deployment, for three paired vehicle tests are presented in Figures 9 through 11.

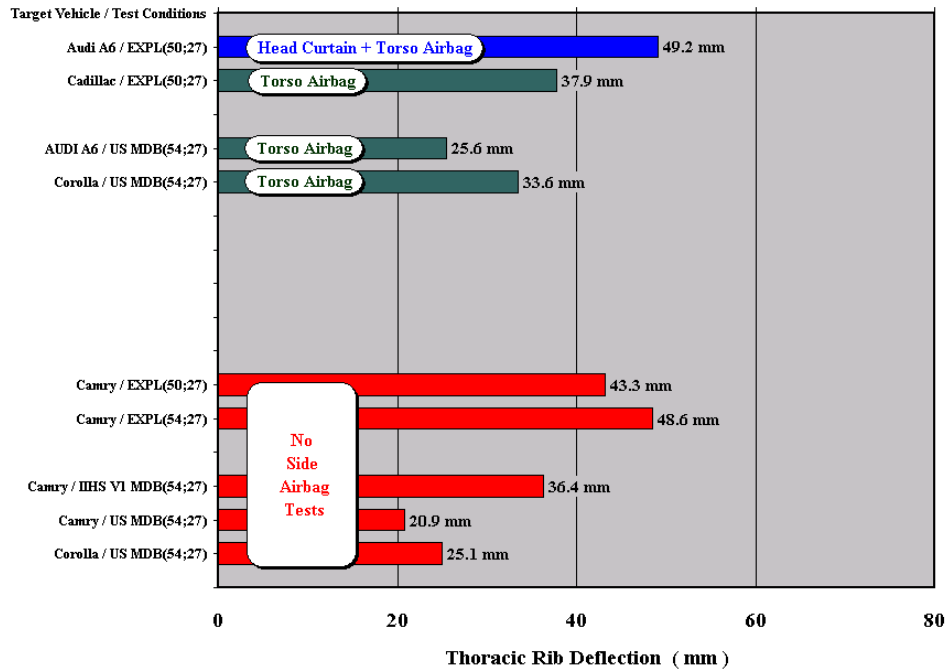
Figure 7. Driver Rib Deflections Observed In Crabbed Explorer and MDB Tests

As shown in Figure 7 it can be seen the peak driver thoracic deflection observed in the Toyota Camry test with the US MDB was 20.9 mm. The crabbed IIHS MBD test yielded a peak deflection value of 36.4 mm.

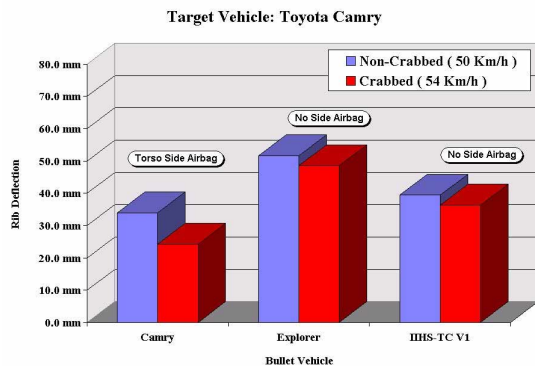
Figure 8. Influence of Crabbing on Thoracic Deflection Values

The peak driver thoracic deflection values observed in tests where the Explorer was crabbed were typically lower, ranging from 37.9 mm to 49.2 mm. However, this in part can be attributed to the fact that three of the four crabbed tests were performed at 50 km/h rather than 54 km/h. The influence of crabbing can be best appreciated by comparing the peak thoracic deflection values observed in the test. These results are presented in Figure 8.

From the results presented in Figure 8, it can be seen that the peak driver thoracic deflections observed in the crabbed tests conducted at 54 km/h were consistently lower than those observed in the perpendicular tests conducted at 50 km/h. However the differences are clearly less pronounced than those associated with the HIC values. The results also highlight the extent to which thoracic injury risk is elevated in SUV-to-car impacts in comparison to car-to-car impacts. In this respect it is also worthwhile to note that, although the peak deflection values observed in tests with the IHS MDB were consistently lower than those produced in the Explorer tests, they nevertheless are approximately twice as high as those produced with MDBs currently used in side impact regulations.

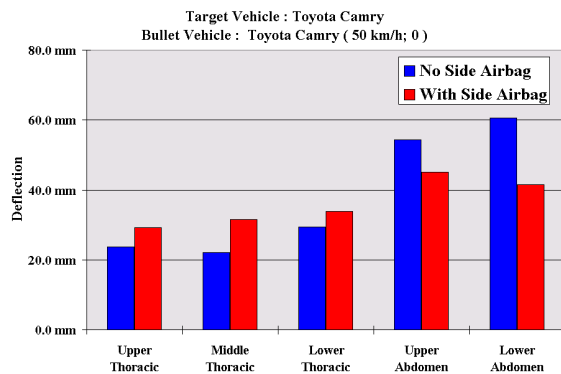
Figure 10. Rib Deflections - Camry Bullet Tests.

the intruding door structure. These variations are determined by the intrusion profile and localized stiffness differences. The intervention of a side airbag typically reduces the deflection gradient observed by virtue of the fact that the loading is now more distributed. The end result is a reduction in the level of compression experienced by those rib elements, which in the absence of the side airbag, would have been subjected to the greatest level of loading. However, the level of rib compression experienced by those rib elements, which in the absence of the side airbag, would have been subjected to the least level of loading, may be increased. Consequently, for the situation where, in the absence of a side airbag, the deflections are greatest in the abdominal region, intervention of a side airbag, may increase the level of compression observed in the thoracic region. This trade-off is illustrated in Figure 10 which depicts the driver rib deflections measured in the Toyota Camry, with and without airbag deployment, when impacted in the side by another Toyota Camry.

Collectively, the data presented in Figures 9 through 11, suggest side airbags afford a net benefit in terms of overall abdominal/thoracic injury risk reduction, but that the level of improvement is very modest in comparison to the potential head benefits.

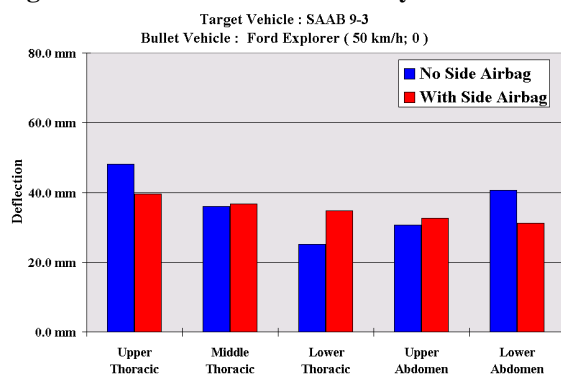
Figure 11. Rib Deflections Explorer Bullet Tests..

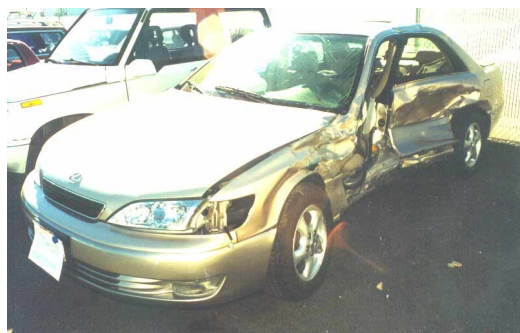
Figure 12. 1998 Lexus ES300.

ASF2-1907 - The driver of a 1998 Lexus ES300 four-door sedan attempted to make a U-turn in the area of a T-intersection on a rural highway. The driver of a following vehicle, a 1989 Mercury Grand Marquis, was unable to avoid a collision and the front of this vehicle struck the left-side doors of the Lexus (09LDAW3). The maximum crush to the Lexus was 38 cm, measured on the left B-pillar at mid-door level.

The driver of the Lexus was a 71-year-old male. He was 175 cm tall and had a mass of 90 kg. His seat was located in the mid-position of its fore and aft travel. The driver was fully restrained and both the front air bag and the torso bag, located in the back rest of the driver's seat, deployed in the crash. The driver sustained fatal injuries and expired en-route to hospital. No autopsy was performed. Notes from an external examination indicated that the driver's injuries included: a laceration and abrasion to the left side of the head from contact with the hood of the bullet vehicle; multiple, bilateral rib fractures; and multiple minor injuries to the chest, abdomen, and extremities due to interaction with the intruding side structure.

The driver was accompanied by a 74-year-old, female, right-front passenger. Her seat was in the mid-position of its adjustment range. The passenger was fully-restrained and her dashboard-mounted front air bag deployed. Following the crash, the passenger was unconscious. She was transported to

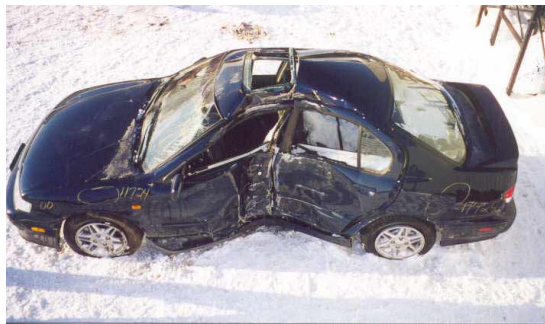
Figure 13. 2000 Infiniti G20t.

ASF3-9624 - The case vehicle, a 2000 Infiniti G20t, was travelling westbound, in the passing lane of a four-lane, median-divided, urban arterial. The vehicle was overtaking a road sweeper when the driver of the truck attempted to change lanes. The left-front corner of the truck struck the right-rear corner of the Infiniti. This contact caused the car to rotate clockwise and mount the central median where the vehicle's left-side struck a light standard. There was direct damage to the left-front door, immediately ahead of the B-pillar, extending up from the door sill to the roof side rail (08LPAW3). The maximum penetration was measured as 43 cm.

The driver was a 48-year-old female, 163 cm tall, with a mass of 55 kg. She was fully restrained with her seat in the rearward of middle position. The combination head-thorax bag deployed from the back rest of the driver's seat. As a result of contact with the intruding side structure of the vehicle, the driver sustained fractures of the left superior-inferior pubic rami with slight displacement; non-displaced, bilateral, impacted fractures of the anterior sacrum; and a 0.5 cm laceration to the occiput.
